Field Trip Guide Hydrogeology of Sinking Valley Pulaski County, Kentucky

American Institute of Professional Geologists, Kentucky Section
October 20, 2011

Ewers Water Consultants Inc., Richmond, Kentucky

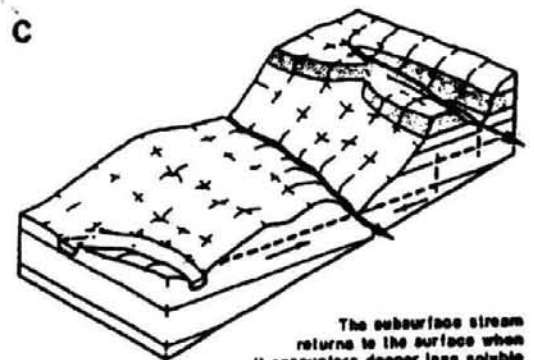
Figure 6

A surface stream breaches the clastic caprock and conduits begin to form along the valley axis and side up-dip toward the nearby surface stream.

The surface stream is captured by the subsurface conduits beneath the valley axis.

The subsurface stream returns to the surface when it encounters deeper less soluble limestone and erosion removes the cavern roof.

THE EVOLUTION OF KARST
IN PULASKI COUNTY, KY

(A) Surface streams originally flowing on the Cumberland escarpment caprock have been lowered by erosion onto the soluble Mississippian limestones. (B) These surface streams have been gradually captured by evolving subsurface conduits, leaving dry valleys where these streams formerly flowed. For the most part, the new subsurface streams parallel their ancestral surface courses. (C) As erosion continued, the lower Mississippian limestones were exposed at the surface. These deeper rocks were poorer cavern formers and the larger subsurface streams were gradually re-established as surface streams.

Surface streams originally flowing on the Cumberland escarpment have been lowered by erosion onto the soluble Mississippian limestones (Fig. 6). These surface streams have been gradually captured by evolving subsurface conduits. This leaves dry valleys where the streams formerly flowed. For the most part, the new subsurface streams parallel their ancestral surface courses. Autogenic waters, those originating as rain on the limestones, are captured by sinks. Allogenic waters, originating as rain upon the nearby clastic rocks of the Cumberland Escarpment, descend into swallets in sinkholes along the eastern portion of the dry valleys.

As erosion continued, the lower Mississippian limestones were exposed at the surface (Fig. 6). These deeper rocks were poorer cavern formers and the larger subsurface streams were gradually re-established as surface streams. Remnants of the subsurface tributaries of these conduit systems are preserved as caves in the Knobs.

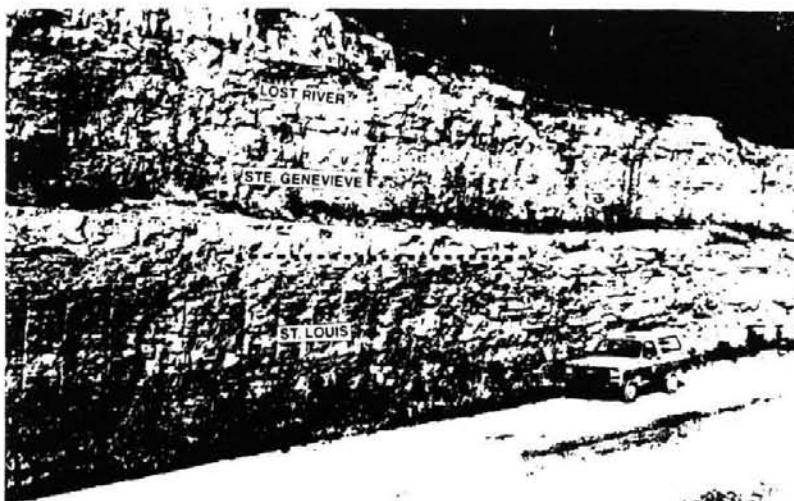
Figure 8 Outcrop at stop 11 (highway mile 5.5) The northern end of the Wabid North roadcut (stop 11 of Dever, et al, 1990).

The Renfro Member of the Slade Formation is at the base of the outcrop to the left (south) of the photograph. The St. Louis and Ste. Genevieve members are shown. A remnant of the Lost River Chert Bed is exposed within the Ste. Genevieve together with associated paleosols. The basal Warix Run Member is exposed at the top, to the left of the photograph.

At this location excellent examples of solution features, typical of the epikarst, can be seen in cross-section. These include the irregular soil bedrock interface, klints, grikes, small shafts, and dissolution widened fissures. Deeper features include anastomoses and bedding plane tubes with active groundwater flow. The groundwater monitoring implications of these features are discussed in the text and in Figure 9.

The upper Renfro, St. Louis, Ste. Genevieve, and basal Warix Run Members of the Slade Formation are exposed here. There is an erosional remnant of the Lost River Chert Bed found in the northern end of this roadcut (Fig. 8). (57.8)
